**ROADWAY AND SAFETY DEFICIENCIES  
I-215 SEGMENT  
3500 SOUTH TO I-80**

Figure 1-7

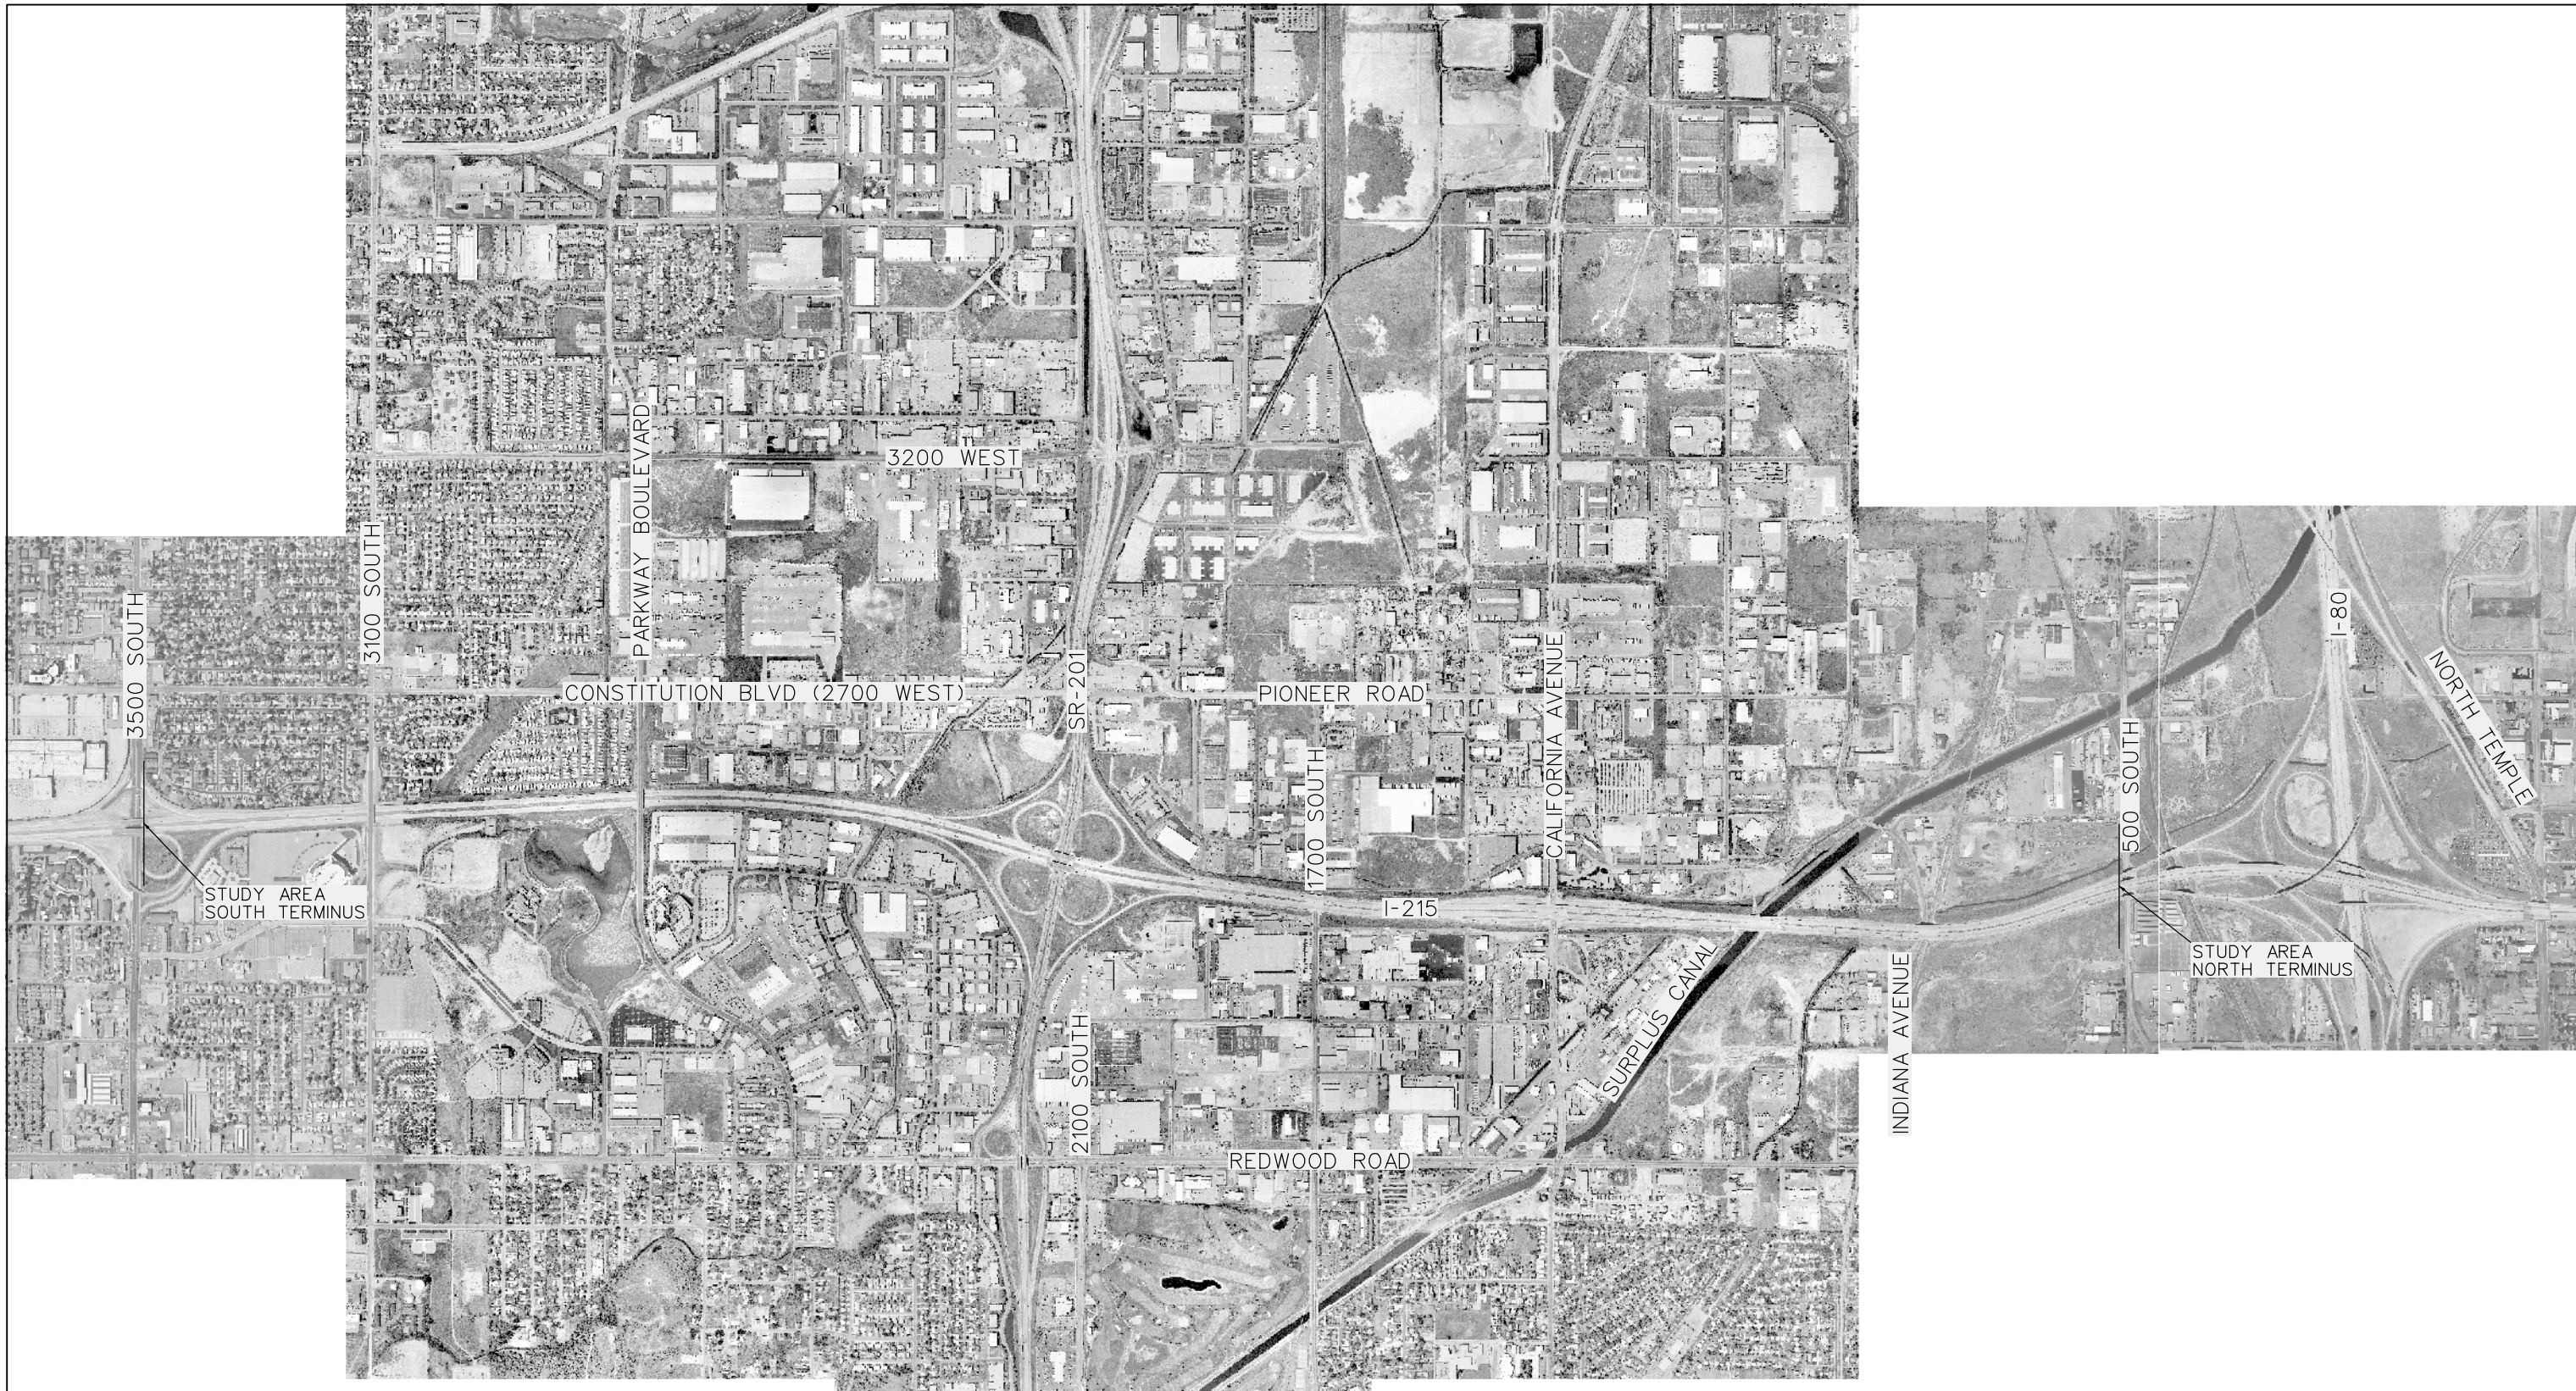
NO DESIGN DEFICIENCIES IDENTIFIED WITHIN THE I-215 SEGMENT OF THE STUDY AREA. FOR DESIGN DEFICIENCIES AT THE SR-201/I-215 INTERCHANGE, SEE FIGURE 1-6.
